Lightning Protection: Getting It Wrong

CHANDIMA GOMES AND MOHD ZAINAL ABIDIN AB KADIR

Digital Object Identifier 10.1109/MTS.2011.941326
Date of publication: 8 June 2011

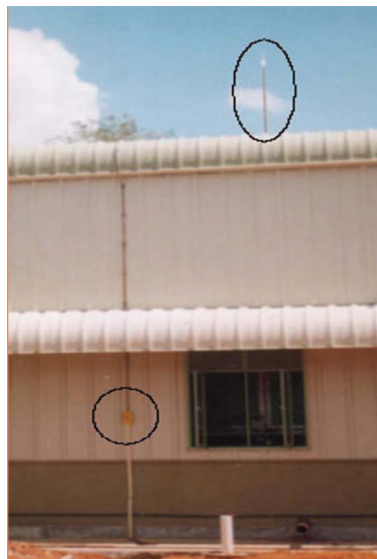
One of the adverse effects of having copper down conductors on buildings made of steel is the rapid corrosion of steel due to the galvanic effect. In most cases, the dimensions of the roofing and supporting materials are well above the minimum values specified in IEC 62305-3 (2006) [15] for being a self-sufficient, air-termination and down conductor system.

However, the unnecessary installation of the LP system causes serious corrosion that damages the building's structure, especially in areas with high salinity and acidity in rain water. In such cases, the only structural LP requirement is a proper grounding system connected to the base of the structure. Fig.1 shows an all-metal factory, a structure made with I cross-sectioned vertical iron struts, L cross-sectioned horizontal iron struts that support the corrugated iron roofing, and sides covered with corrugated metal sheets. The structure only needs grounding of vertical struts at the base level at regular intervals as per [15]. The vendor has installed 4 ESE air-terminations grounded by bare copper tapes laid along the metal roof and facades. Note that the aluminium casing of the test joint, which is fixed to the facade by nuts and bolts, causes even worse corrosive problems due to the presence of several metals together.

Fig. 1. An all-metal structure (supporting struts, roof, and facades) installed with ESE air terminations and bare copper down conductors in contact with the building material. The air termination and aluminum test joint box are shown highlighted with black circles.

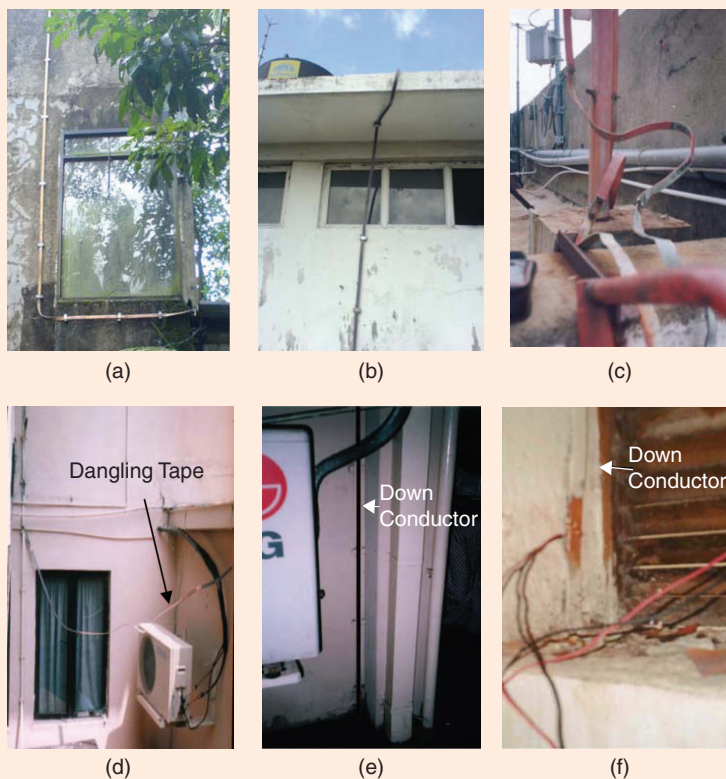
- 1) *Improper installation and maintenance of down conductors:* Down conductors have been observed with twisted, crooked and loosely hanging parts, U and L bends, undetectable ground termination, fixing brackets of different metals, and parts inside cable ducts or installed close to equipment. Examples of several of these drawbacks are depicted in Fig. 3. Another issue, the installation of insulated cables in metal towers, is discussed in detail in [17].

Fig. 3. Erroneous installation of down conductors. a) Right-angled bend about 3-m above ground level. b) U bend close to windows. c) Crooked and twisted down conductor. d) Loosely hanging part of a down conductor. e) Down conductor running very close to an entrance and to electrical equipment (down conductor is highlighted by a black line). f) Down conductor where the ground termination cannot be traced.

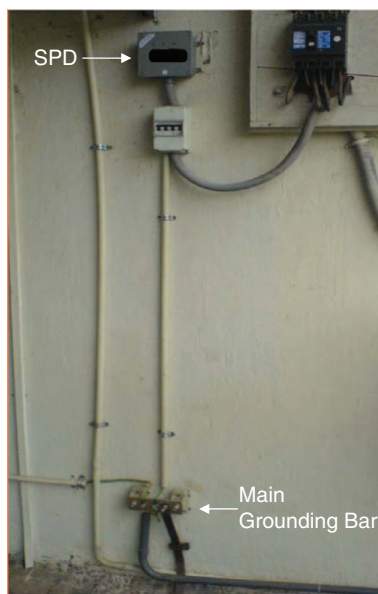
- 2) *Misconceptions of grounding:* Apart from the multi-point earthing problem mentioned above, one of the most confused grounding issues, especially among junior engineers, is the maximum distance (50 cm) recommended for the grounding of SPDs. The Standards [18] clearly mention that the length of wire between the SPD and the grounding bar (which provide ground reference for the equipment to which power is supplied from the same panel) should be less than 50 cm.

Unfortunately some technical personal understand this as a 50-cm maximum length between the SPD or grounding bar and the earth. Fig. 4 shows a ridiculous attempt made by the technical personnel of an institution in South Asia to achieve this misunderstood concept. Several other erroneous practices with regard to the same issue have been discussed in detail in [19].

Fig. 4. Misunderstanding of standards. The technical personnel who designed this installation successfully achieved (as he understood) less than 50-cm tape length between the main grounding bar and the earth. The incorrect positioning of the main grounding bar makes the wire length between the SPD and the main grounding bar more than 2 m, which is a Standards violation [15]. At such a location with no space restriction the designer could have easily planned the positions of both the SPD and the main grounding bar to be well in compliance with the recommendations of [15].

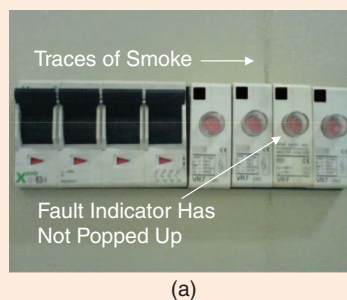
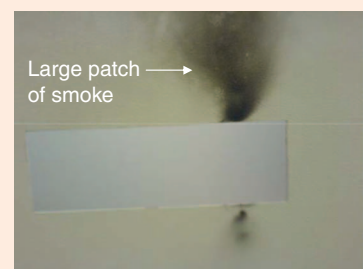
we noticed that one of the SPDs in the panel showed burn marks in the panel and also in the panel cover. However, the fault indicator of the SPD (the red button that should pop out in the event of SPD failure) indicated that it was in good condition. This prompted us to ask the technical personnel of the institution to remove the SPD from the panel and split it open to inspect inside. We could see only a partially melted lump of PVC-like material inside.

There were no signs of any surge protective components such as MOVs, GDTs, or Zener diodes. We could not get photographs of the split-opened device as per the request of the technical staff.

Fig. 5. a) Damaged SPD with faked brand name. Note that the fault indicator has not been popped up irrespective of arc signs. The defective SPD is discolored showing signs of internal heating, which was verified on opening the device. b) Cover of the panel with large patch of black smoke. (The smoke patch coincides with the location of the damaged SPD).

the genuine products. The only advice that we give in this regard is to buy products from authorized dealers; however, this may not be 100% foolproof.
